Big Creek Restoration: AMD & Beyond

(collaboration among DRN, SCD, SH, PADEP/BAMR, and others)

July 12, 2022

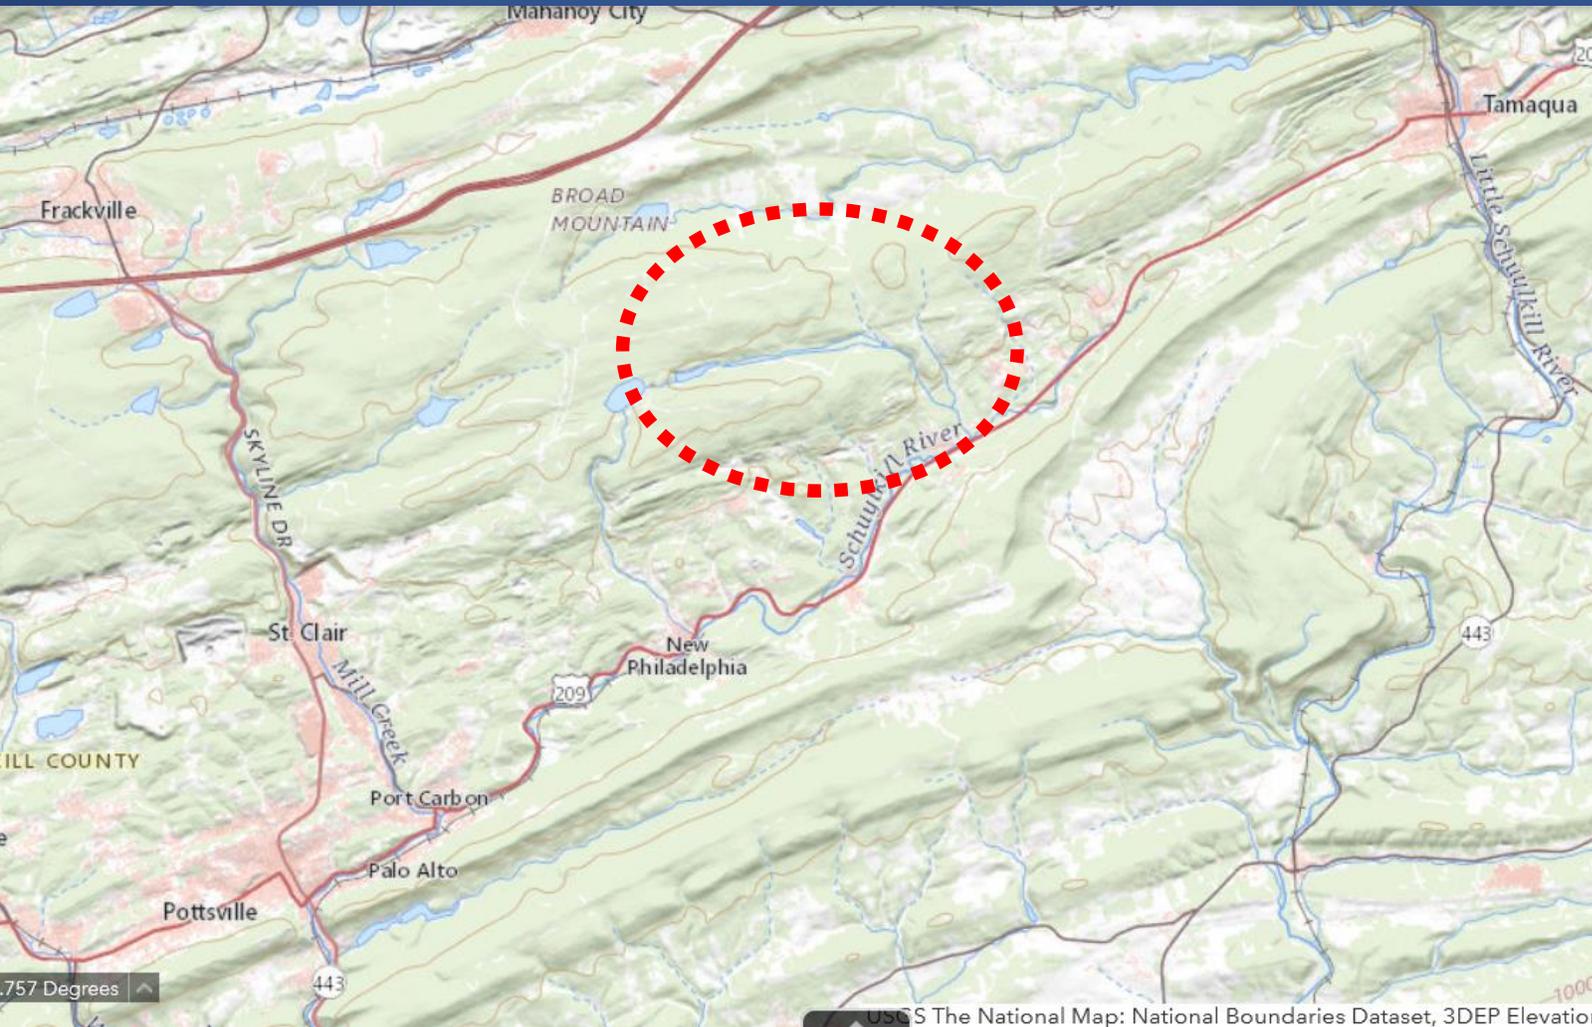
- 3.7 mi² drainage area, nearly 100% forested
- Blythe Twp Mun Auth source water (one of three)
- 19 acre flooded strip mine in the headwaters (Capparell stripping pit)
- TMDL & WIP identify Big Creek as among the largest untreated sources of acidity & aluminum loading
- Biological community highly altered, including lack of fish life and severely altered stream insect community

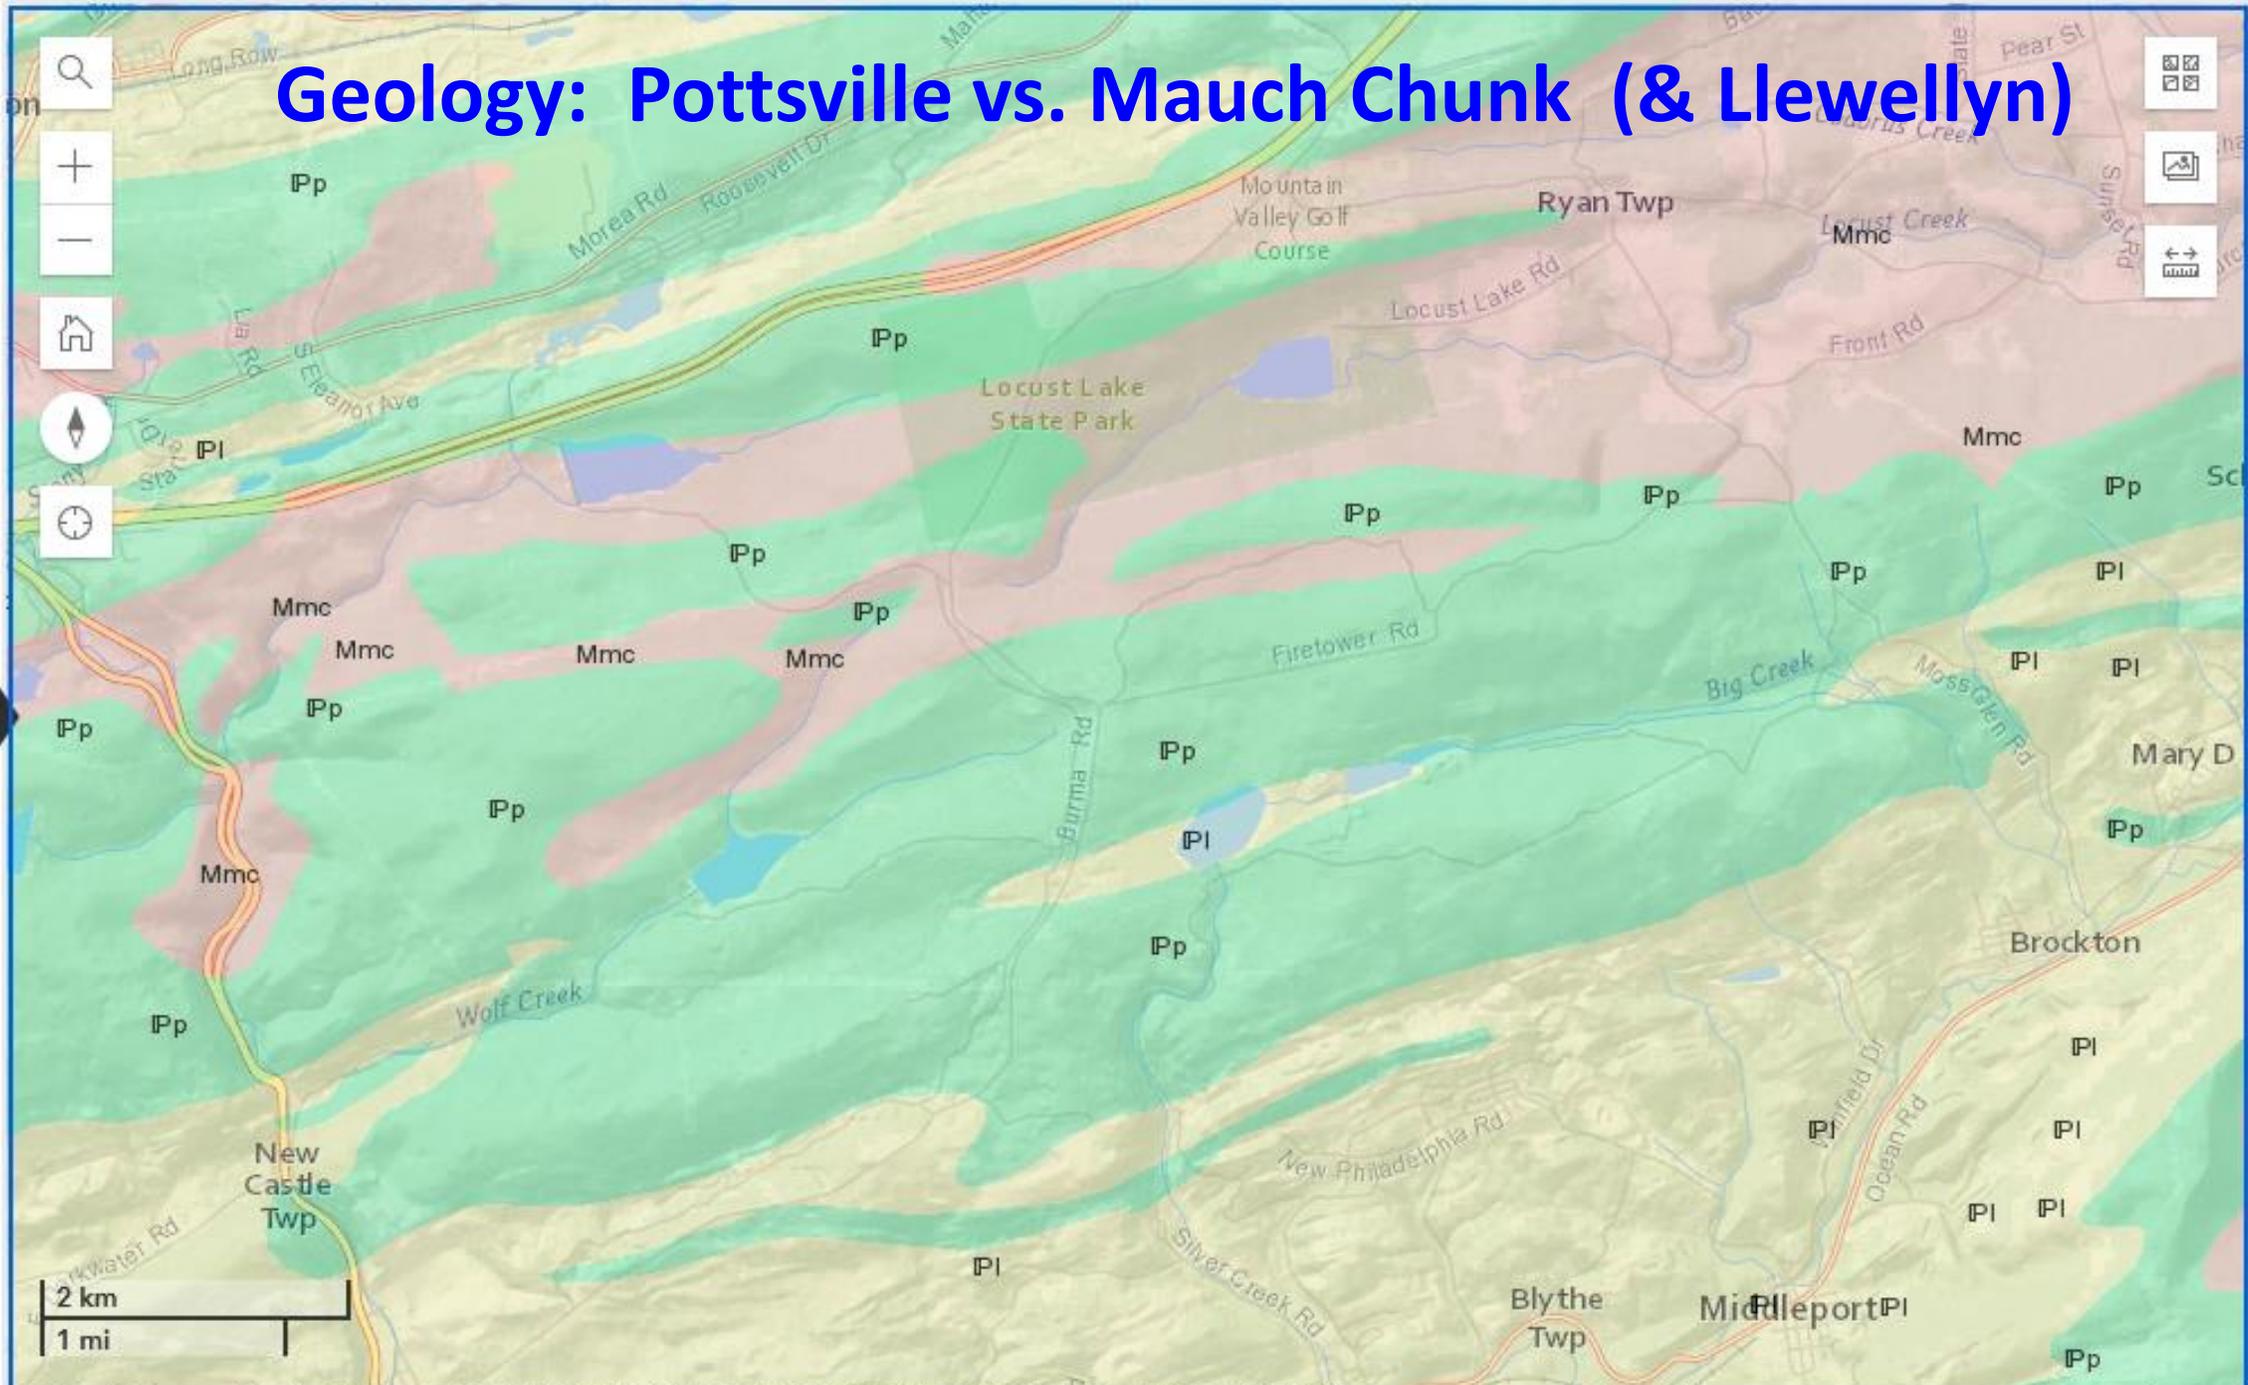
Geology: Pottsville vs. Mauch Chunk (& Llewellyn)

- Pottsville Formation appears to provide no buffering, and may actually lead to further acidification
- Matt Shank (PADEP, WQ Assessment) is finding general pattern in multiple Formations in Pennsylvania (2022 or 2023 report expected)
- Dr. Pete Sharpe (NPS) working on similar watershed in Shenandoah Nat'l Park

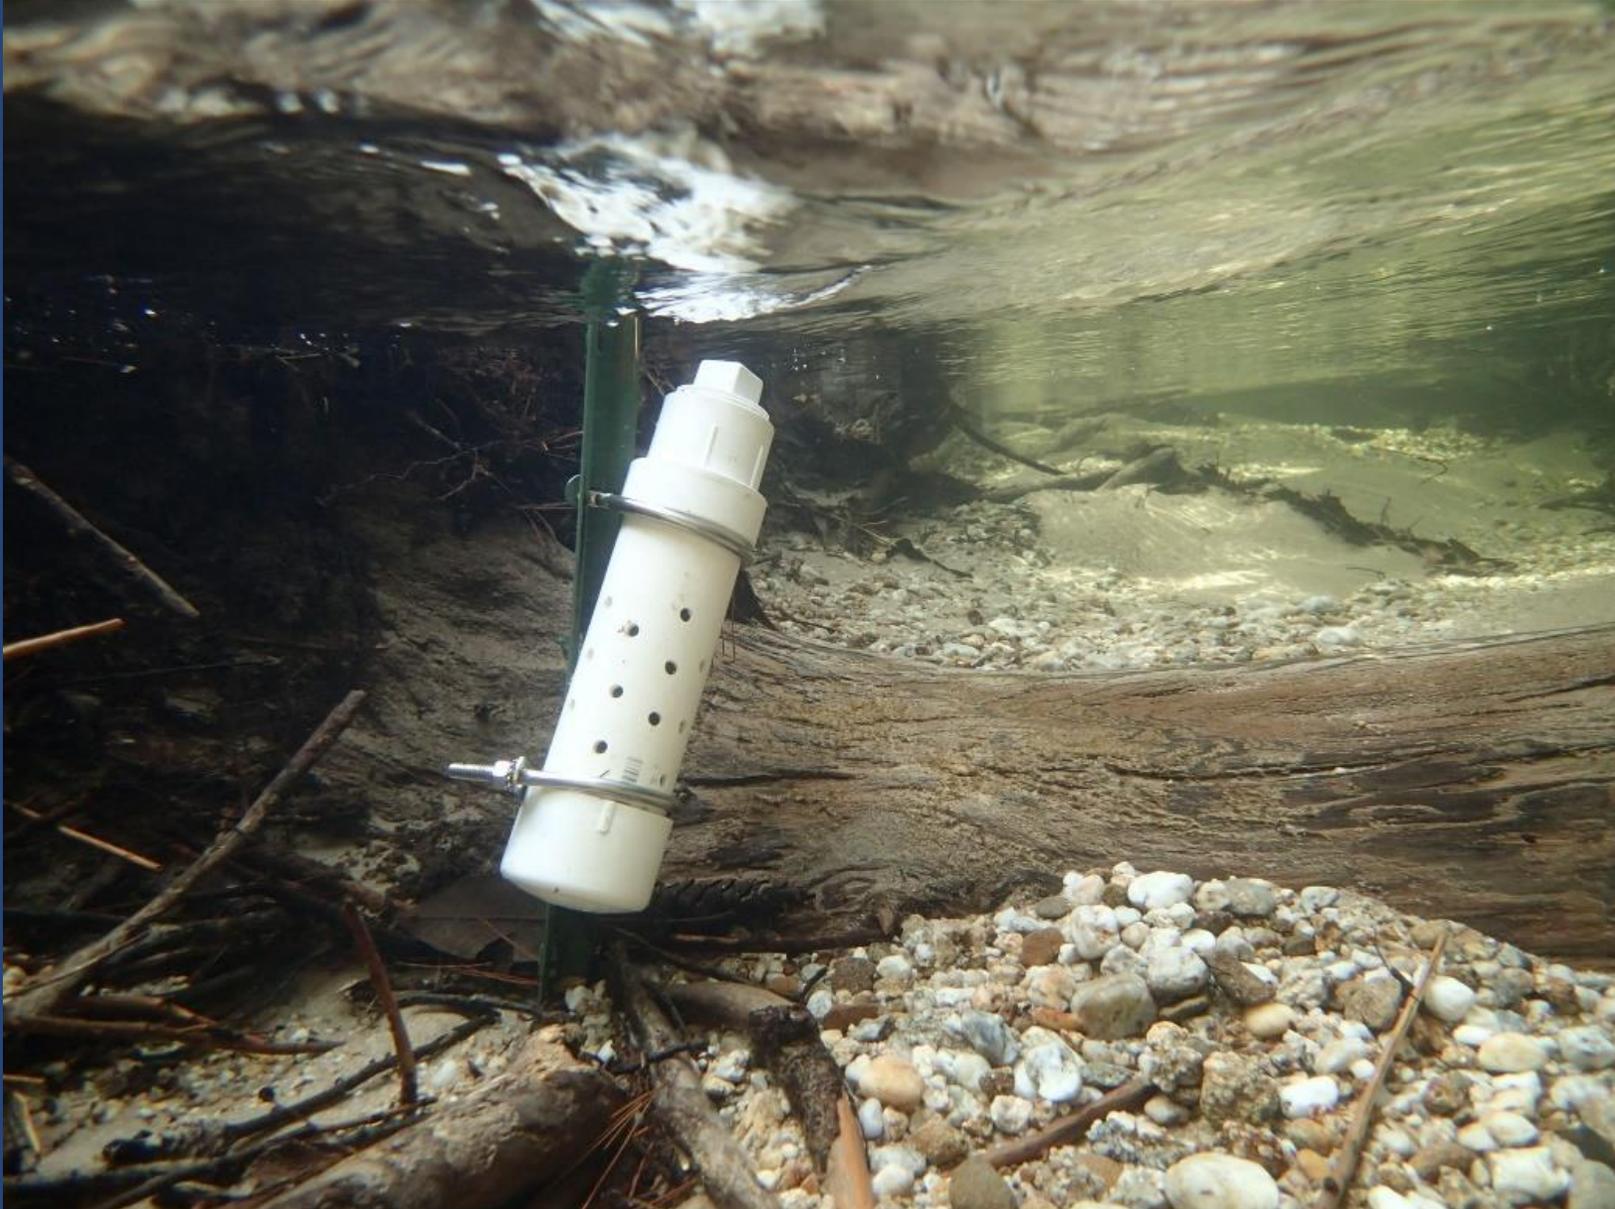
3. Continuous pH Sensors

- Onset / HOBO MX2501
- Uncertain use in low-conductivity water
- 6 months replacement for sensor (\$120)
- calibrations at 2-4 weeks

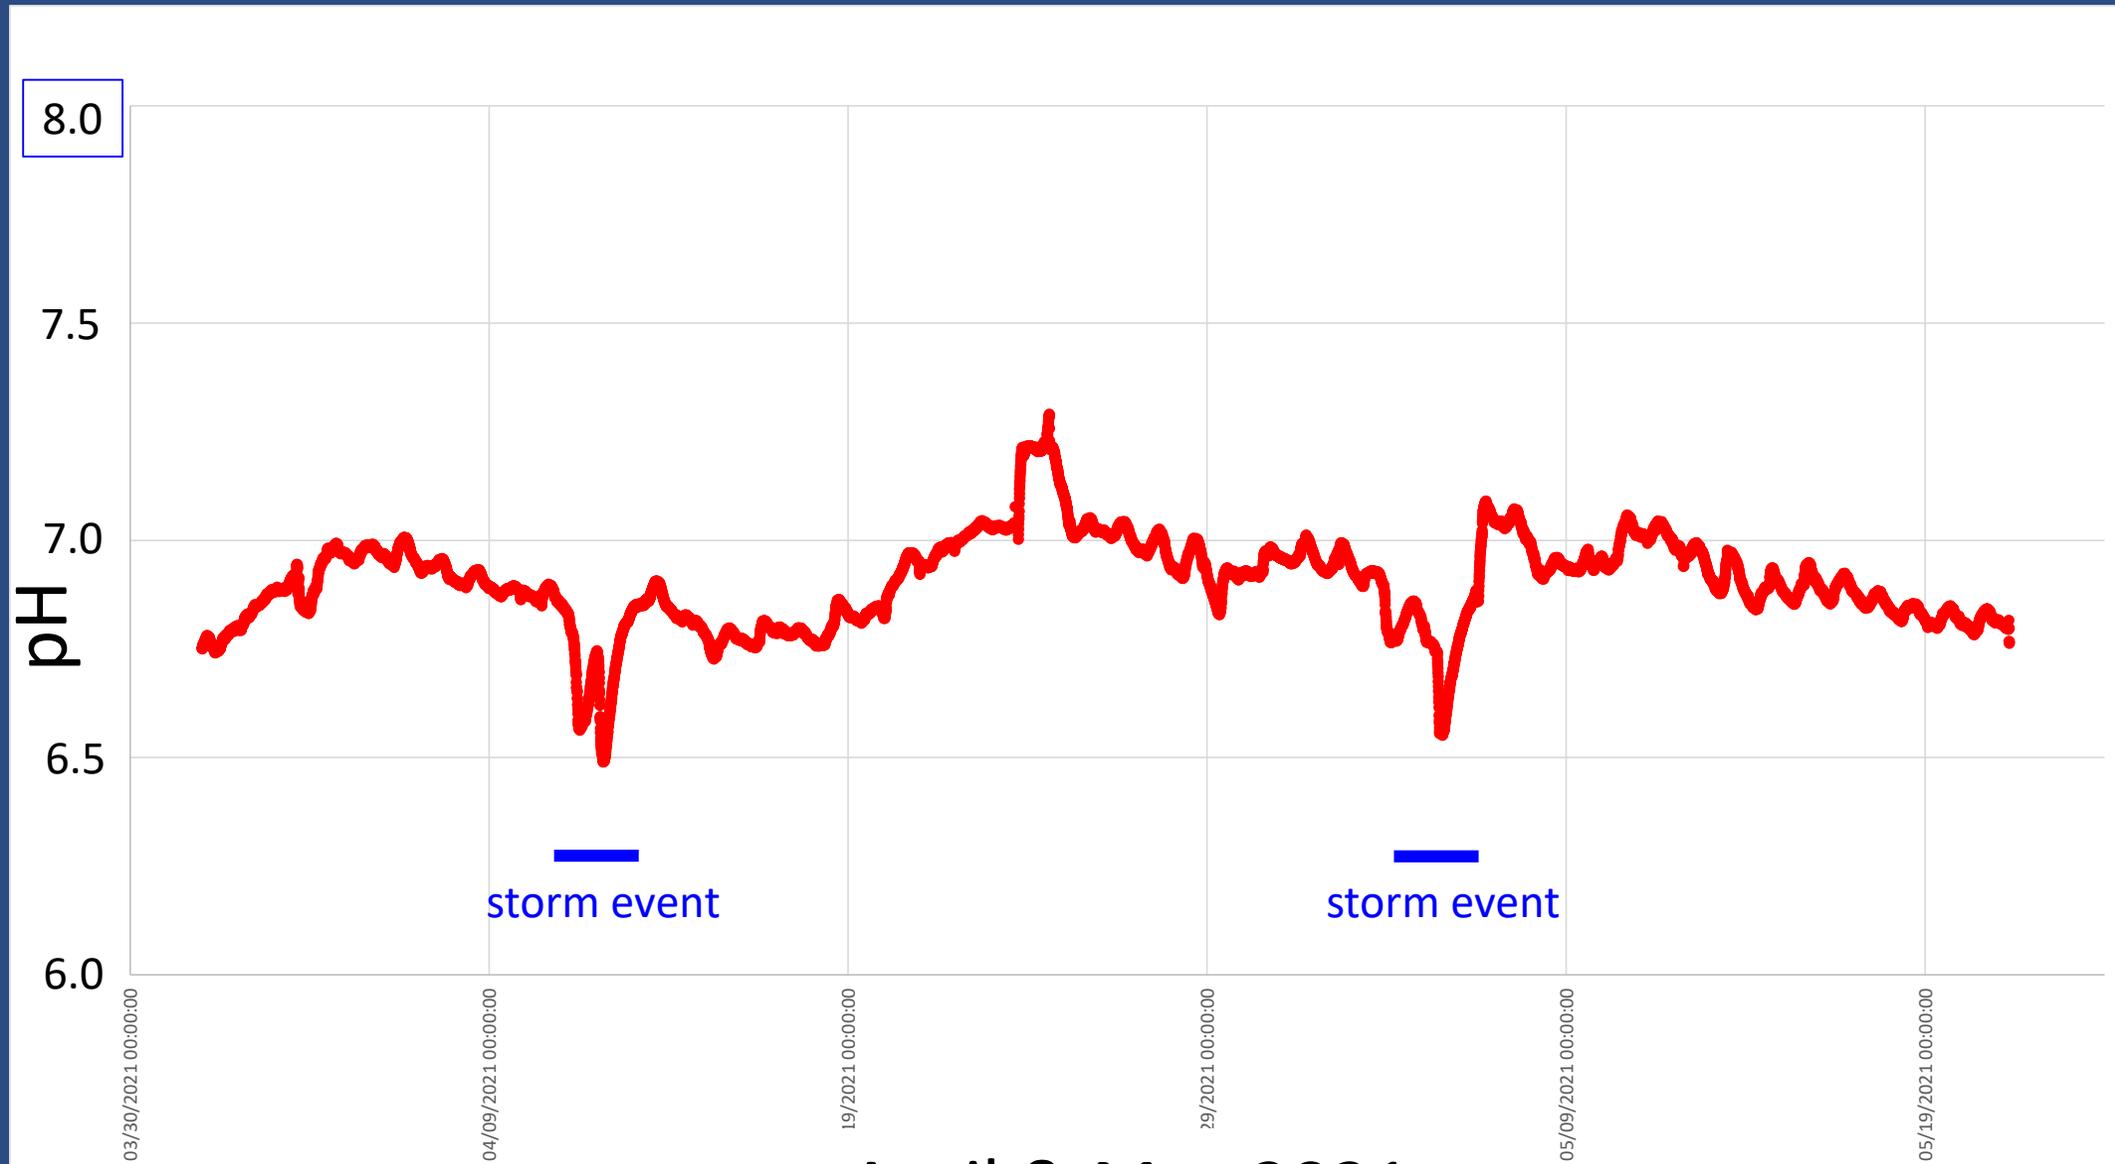
Big Creek above Moss Glen Reservoir

April & May 2021

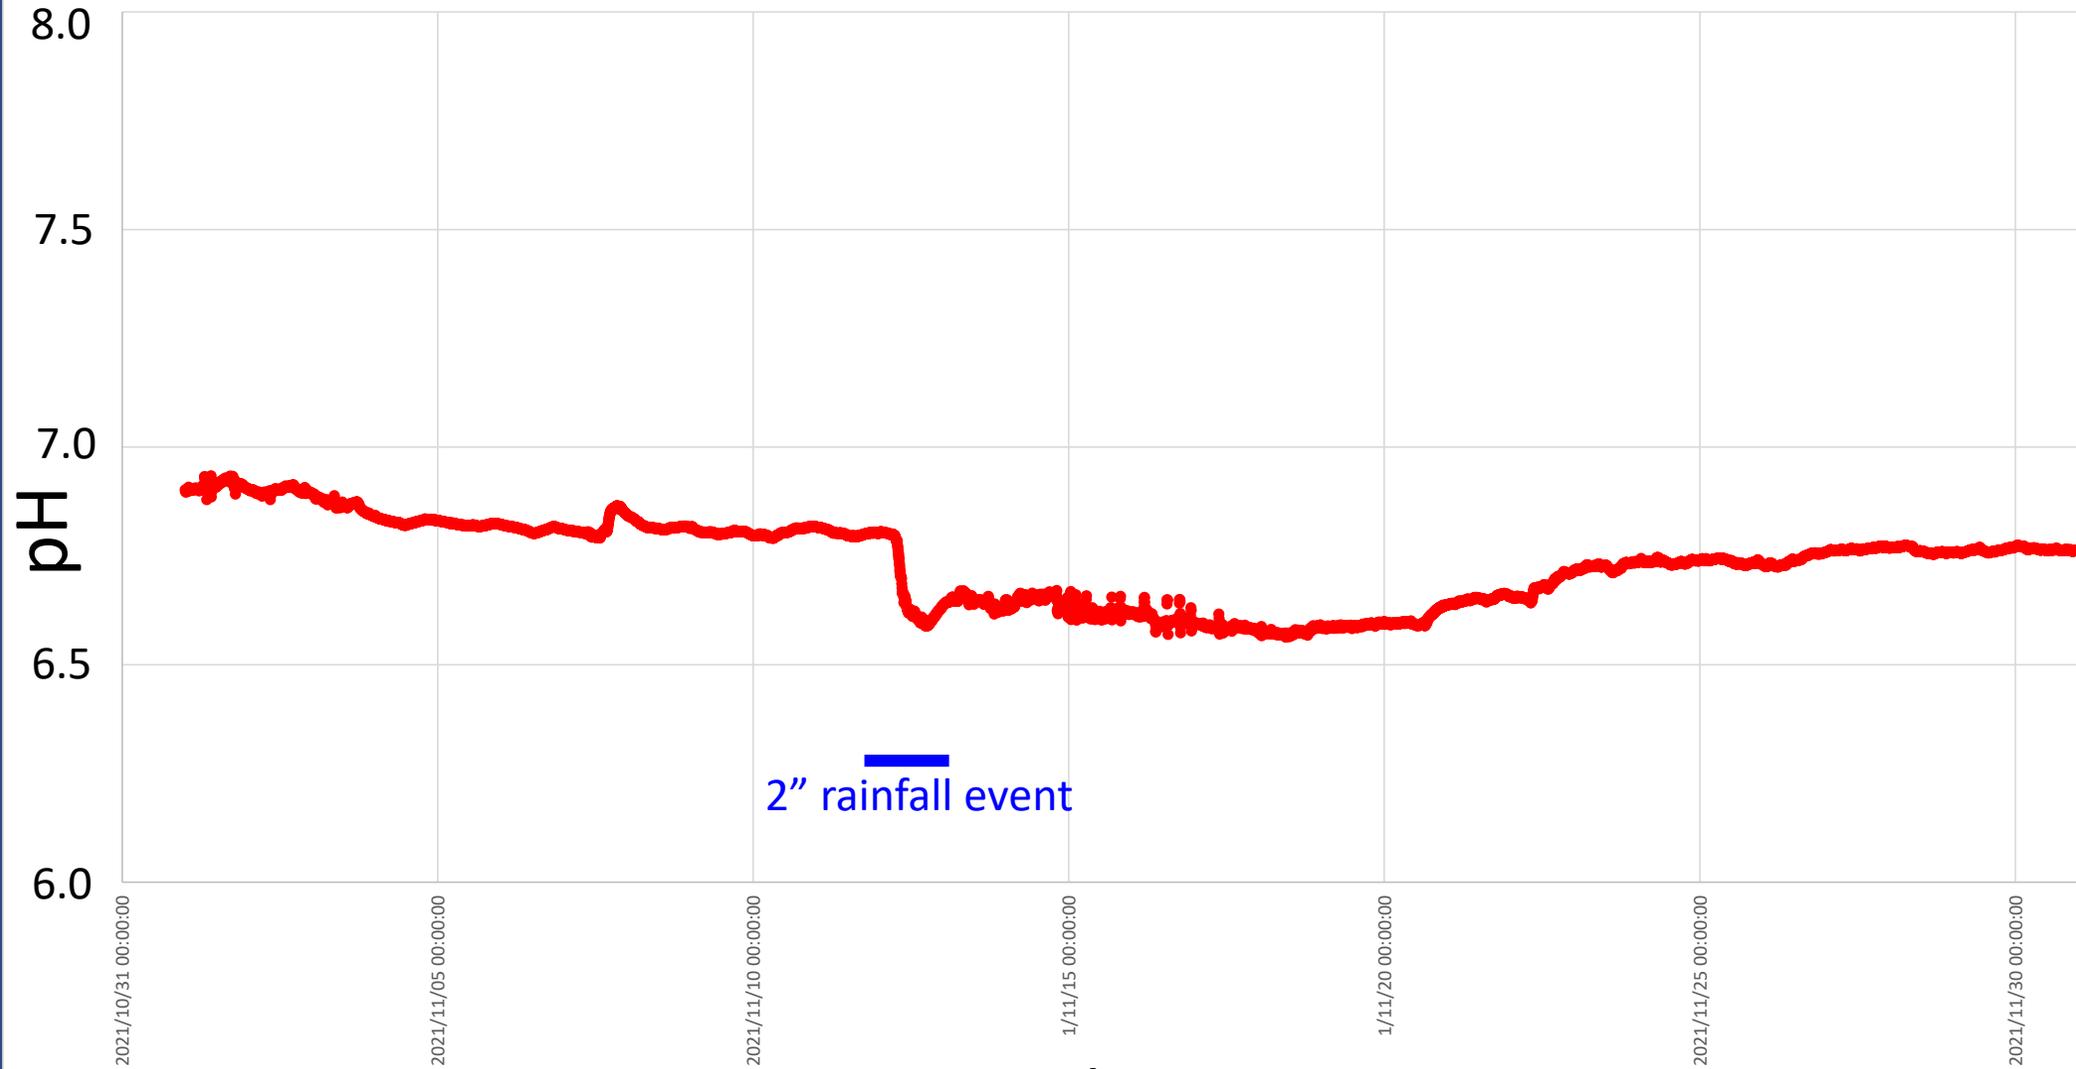
Big Creek above Moss Glen Reservoir

November 2021

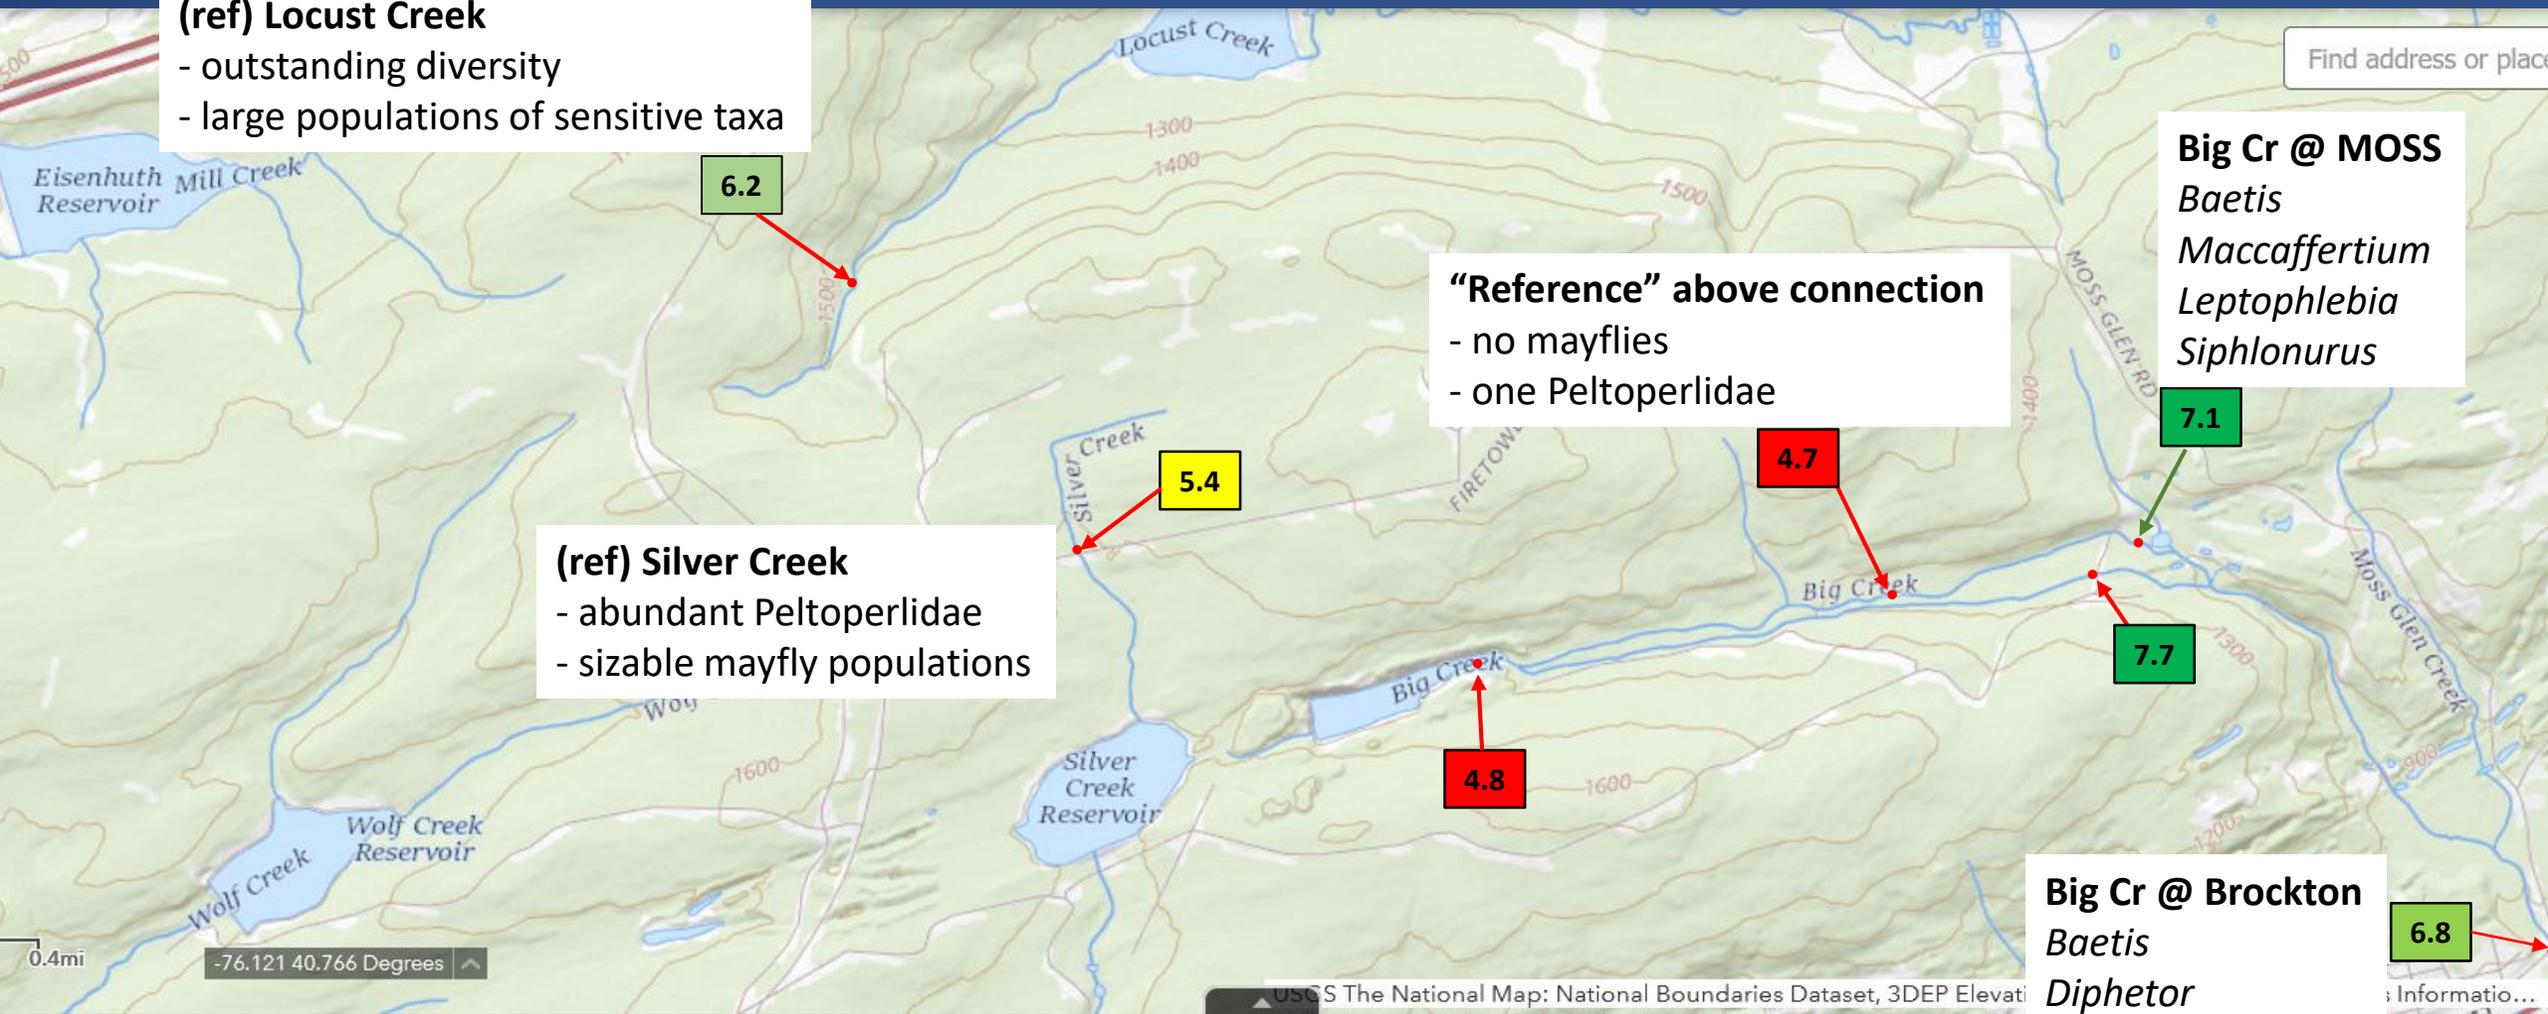
Benthic Macroinvertebrates (and pH snapshot from May 2021)

- outstanding diversity
- large populations of sensitive taxa

- abundant Peltoperlidae
- sizable mayfly populations

- no mayflies
- one Peltoperlidae

- Baetis*
- Maccaffertium*
- Leptophlebia*
- Siphonurus*

- Baetis*
- Dipheter*
- Eurylophella*
- Maccaffertium*
- Leptophlebiidae
- Siphonurus*
